Hatton Mains, Kirknewton
Edinburgh,
Stage 1 Land Contamination
Report

PROJECT TITLE: Proposed Residential Development
Hatton Mains, Kirknewton, Edinburgh

REPORT TITLE: Stage 1 Land Contamination Report

PROJECT REFERENCE: 7485/2

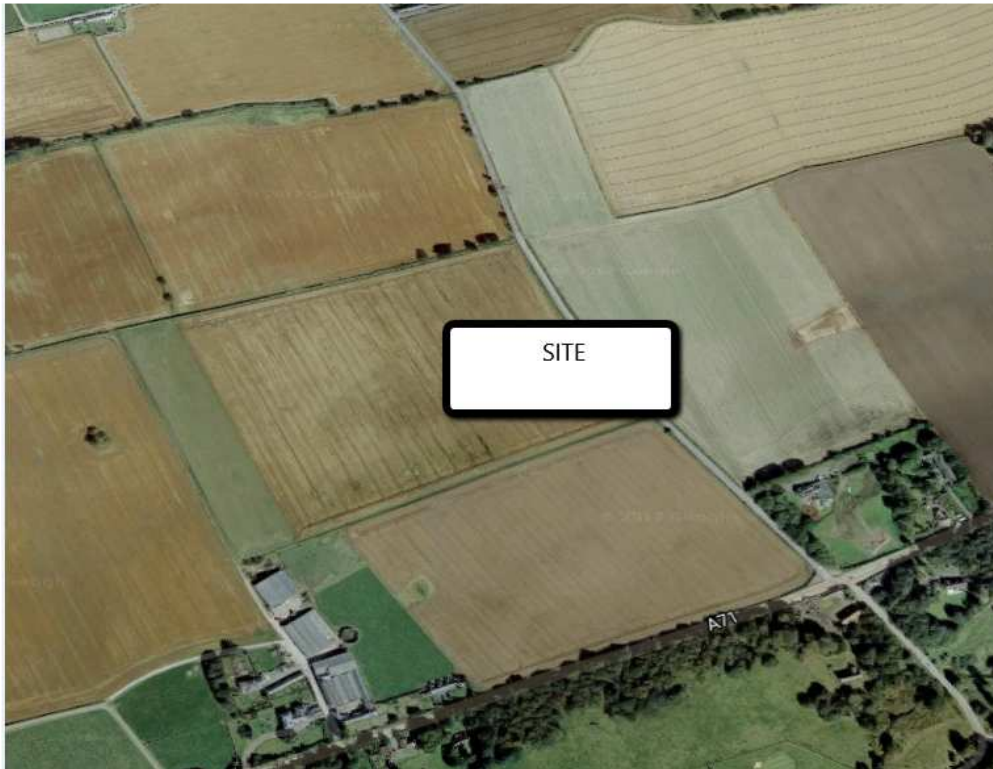
AERIAL VIEW

- 3.1** The site is located at OS Grid 314290, 669534; Post Code EH27 8EB and is currently a series of undeveloped fields as shown in Appendix A.
- 3.2** The proposed residential development is to be constructed on the aforementioned undeveloped fields.
- 3.3** To the North, West and East are located open countryside with scattered residential dwellings. To the South is the Dalmahoy Country Club and Golf Course.

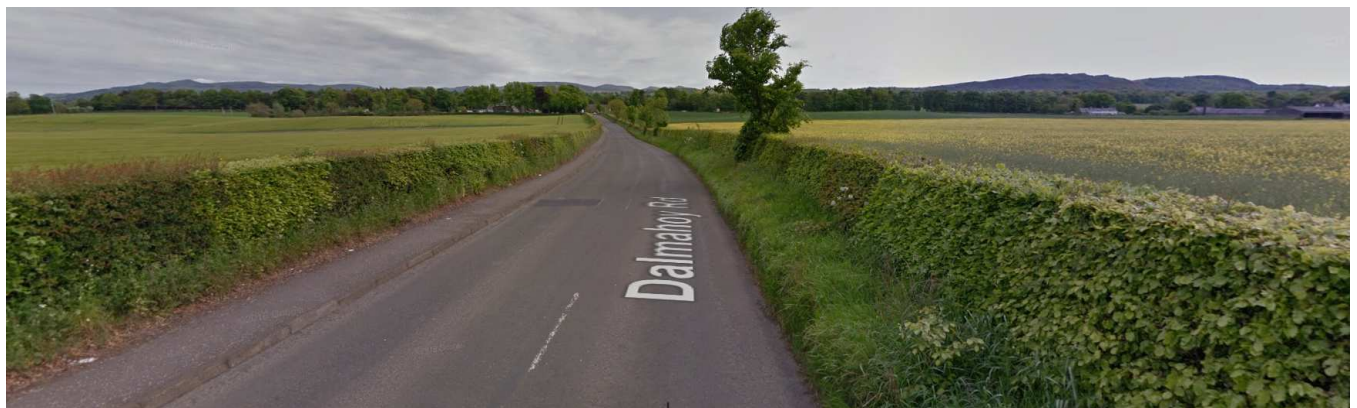
VIEW OF SITE FROM NORTH

- 7.1 The site is occupied by an undeveloped field and the old maps indicate the same usage from at least 1894 to the present.
- 7.2 The site itself appears of a level grade and there was no obvious evidence of water ponding on the site.
- 7.4 Photographs of the site can be found in Appendix A.

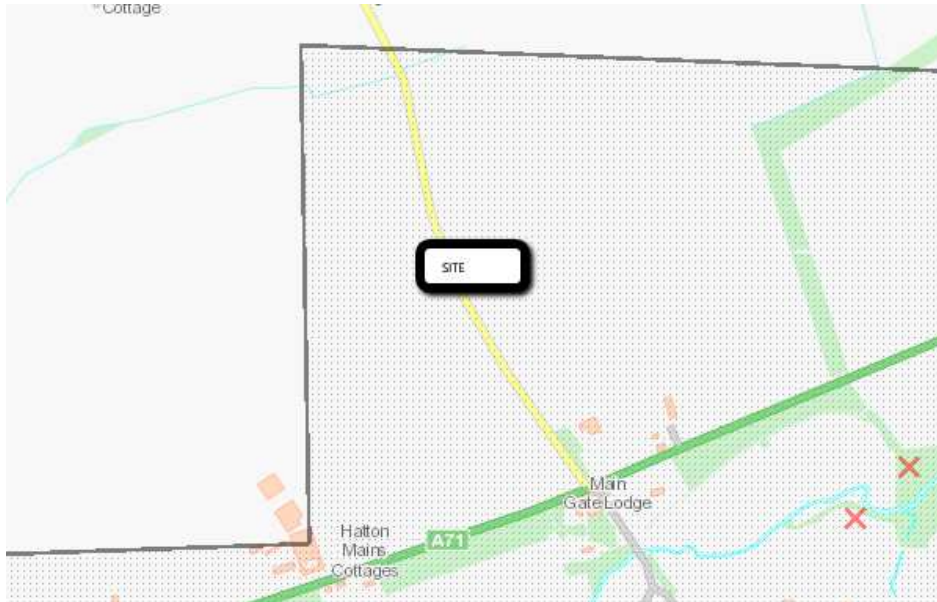
Coal Mining Data

- 10.1** The mining plan in Appendix F notes the site is within a coal mining reporting area.

- 11.1** We have assessed the site as negligible with regards to the presence of ground soil contaminants with no requirements for on-site testing.
- 11.2** We have assessed the site as low risk regards flooding with no requirements for further investigation.
- 11.3** We have assessed the site as low risk regarding shallow mine workings with no requirements for further investigation.

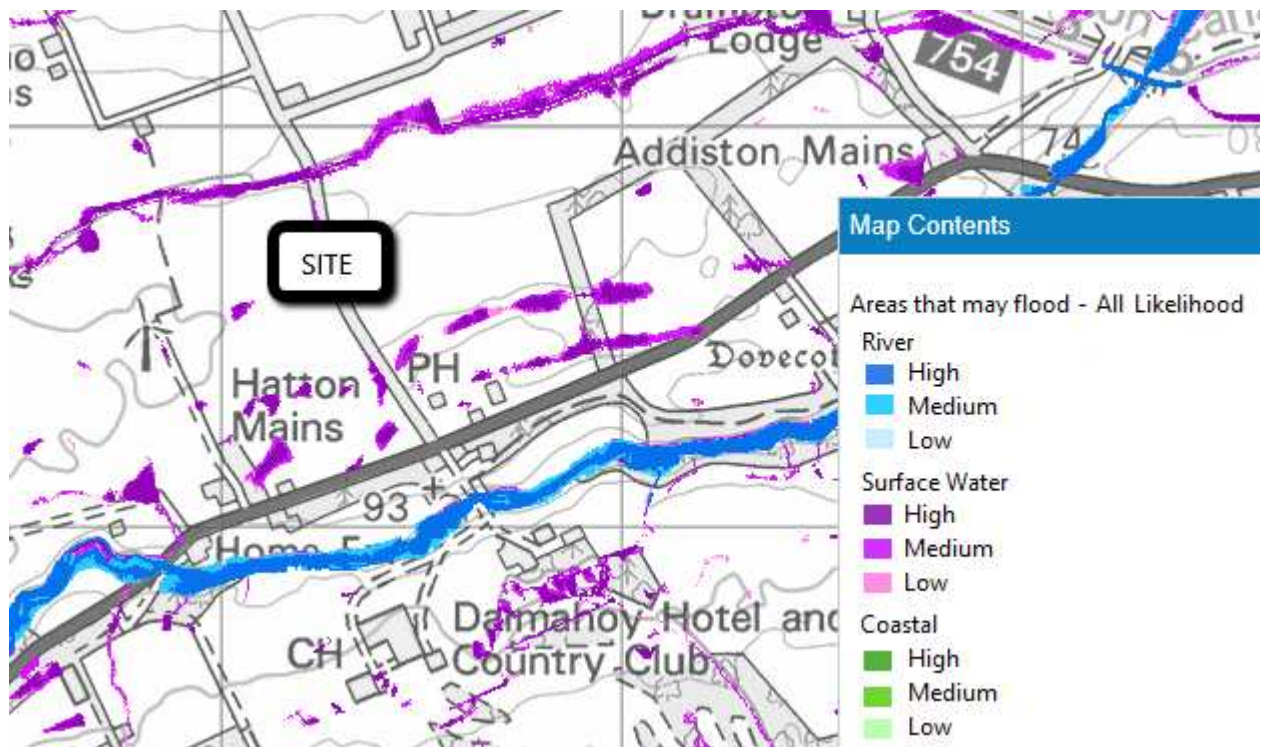
- 6.1 With reference to SEPA's Indicative River & Coastal Flood Map the site is situated out with any indicative flood risk. Appendix G
