HATTON MAINS, EDINBURGH

PHASE I

GEO-ENVIRONMENTAL DESK STUDY REPORT

Project Reference: P18/320

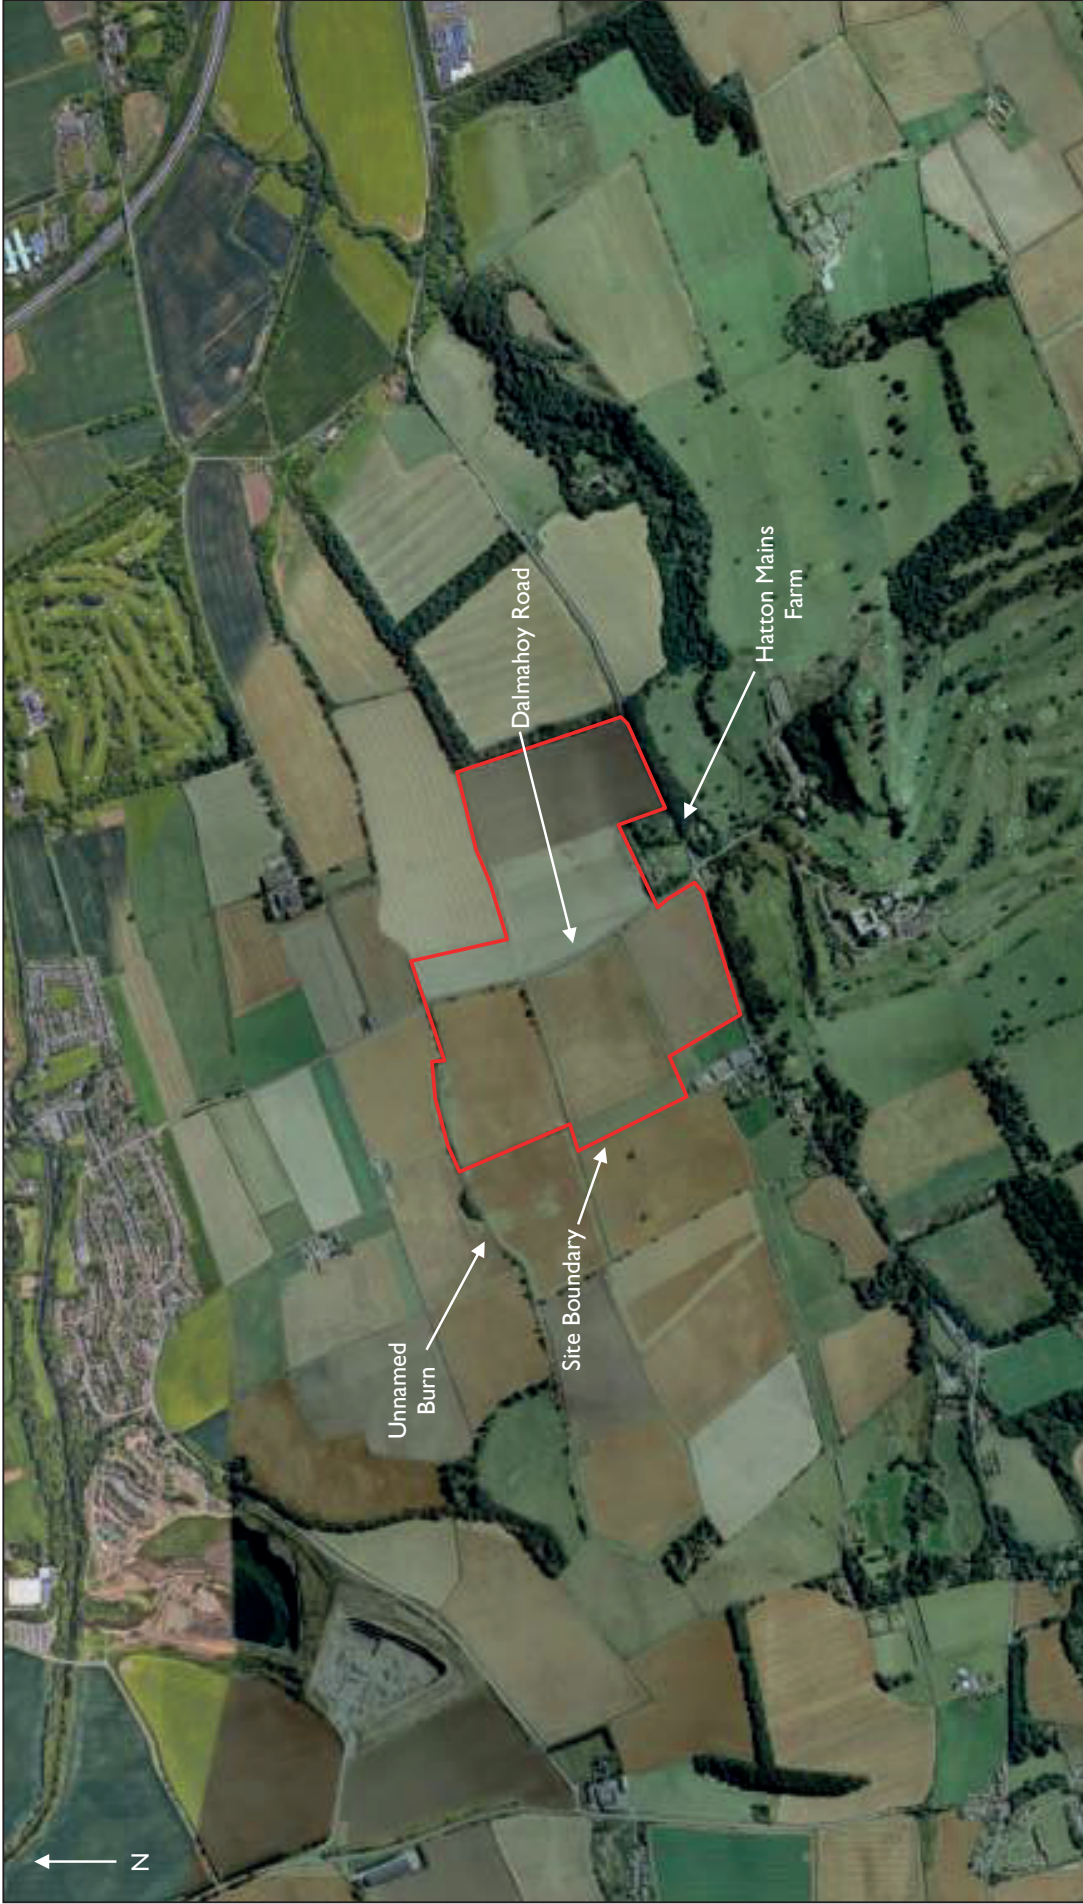
Plate 01 - Aerial view of the site (Courtesy of Google Earth)

Site Name:	-	Hatton Mains, Edinburgh
National Grid Reference	-	278000, 609590.
Total Site Area:	-	59.3 Ha (approximately).
Local Authority	-	Edinburgh City Council.
Current Usage	-	Undeveloped agricultural land.
Access	-	Accessible via Hatton Mains Farm, off the A71, and from Dalmahoy Road
Surface Conditions	-	crops, surface grass and vegetation – agricultural fields. Dalmahoy Road (tarmac) is aligned north-south in the central site area.
Topography	-	The site was noted to be undulating, with a number of small mounds and valleys, particularly aligned through the southern and north western site area. Site levels were noted to vary between 82.00 m AoD and 98.00 m AoD. (Due to the variable topography, significant future earthworks may be required).

North	-	Agricultural land with farm dwellings, with an unnamed burn along the northern site boundary. A quarry is recorded 700 m northwest.
South	-	Generally agricultural land, with Gogar Burn recorded 136 m south of the site. Dalmahoy Golf Club located 250 m south.
East	-	Agricultural Land.
West	-	Agricultural Land.

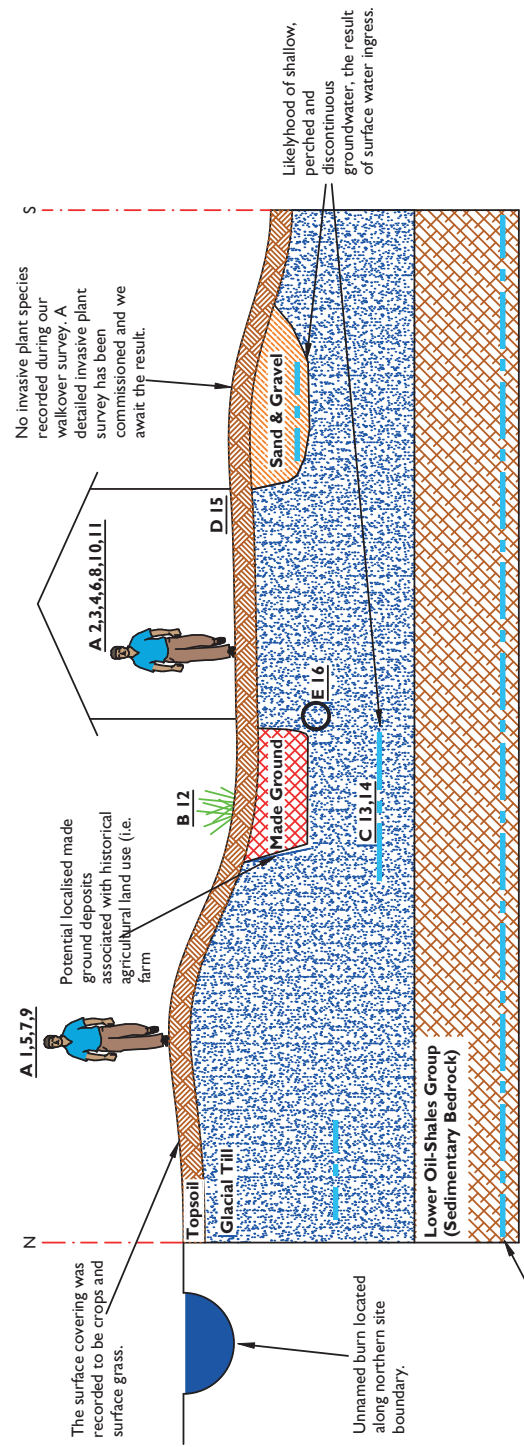
Potential Receptors

- A. Site users / construction personnel.
- B. Vegetation / fauna.
- C. Groundwater.
- D. Buried concrete (Service and foundations)
- E. Plastic water supply pipes.

5.2.4 The presence of all three elements identifies a plausible pollutant linkage. An assessment of the potential sources, pathways and receptors constitutes a conceptual model for the site.
